**TR-328
2008**

Water Loss Test Results for Lateral A Before and After Lining Hidalgo County Irrigation District No. 2

February 6, 2006

Water Loss Test Results for Lateral A Before and After Lining Hidalgo County Irrigation District No.2

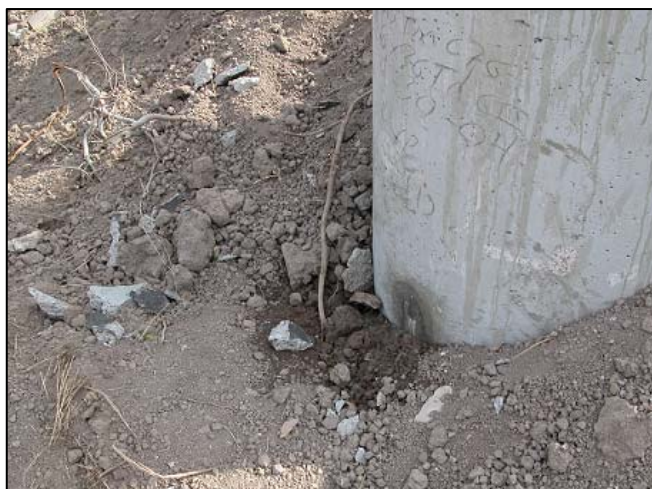
Leaks were discovered at several gates and valves with in the test segment. However, these losses could not be accounted for due to the difficulties in obtaining measurements.

Figure 11. This photograph shows a standpipe connecting off of Lateral A-8 leaking during test. Leaks like this are very difficult to measure and are usually hard to notice.
